GUANTANAMO
NAVAL STATION
SEWER OUTFALL
INVESTIGATION

BY
T. J. O'BOYLE

FP0-1-81 (13)
JUNE 1981

OCEAN ENGINEERING
AND CONSTRUCTION PROJECT OFFICE
CHESAPEAKE DIVISION
NAVAL FACILITIES ENGINEERING COMMAND
WASHINGTON, D.C. 20374

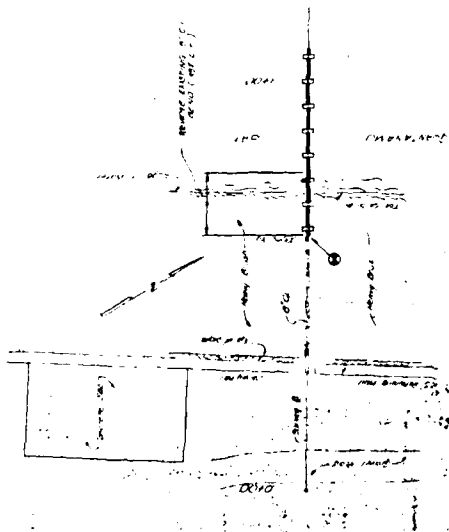
OUTFALL NO. 14

14.	The C.I. pipe is broken prior to going into the water.	There is no evidence that this outfall is now used.
15.	Looks good as it enters the water.	End of the outfall looks clear.
